Manhole Inspection Summary

Manhole # S41AA_038MH

Insp Date: **8/6/08 10:07 AM**

Location Address: **738 wharton ct**

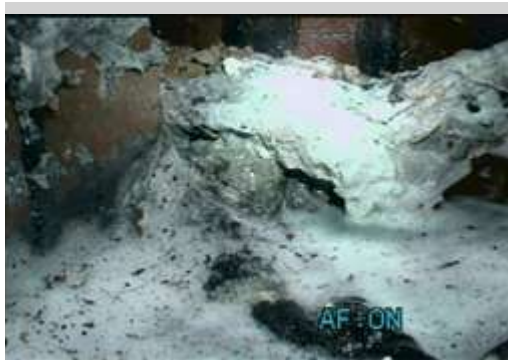
Defect 4

Condition: ☐ Sound ☐ Cracked ☐ Root Intrusion ☐ Deteriorated ☐ Leaks ☒ **Debris**

channel debris

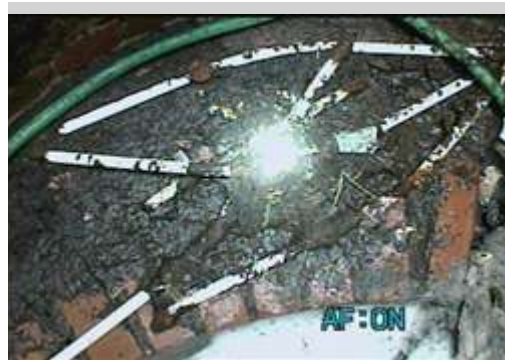
Defect 3

Condition: ☐ Sound ☐ Cracked ☐ Root Intrusion ☐ Deteriorated ☐ Leaks ☒ **Debris**

bench debris

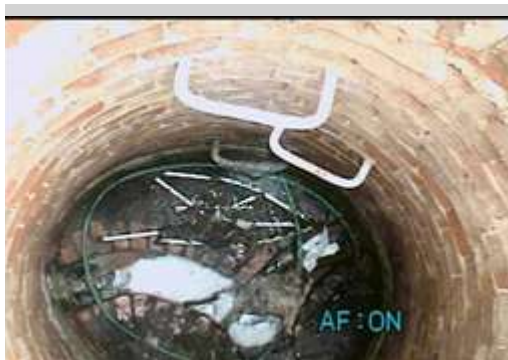
Defect 2

Count: **3** Missing: **0** ☒ **Corroded**

☒ **Evidence Of Surcharge** Depth: **4** (ft.) ☐ Active Surcharge Present

steps corroded, surcharge evidence

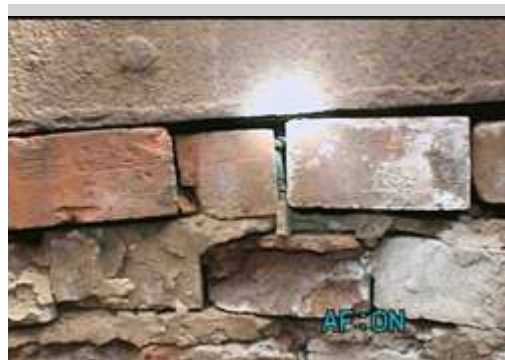
Defect 1

Condition: ☐ Sound ☐ Cracked ☐ Root Intrusion ☒ **Loose Brick** ☒ **Deteriorated**

loose bricks, deteriorating, frame adj

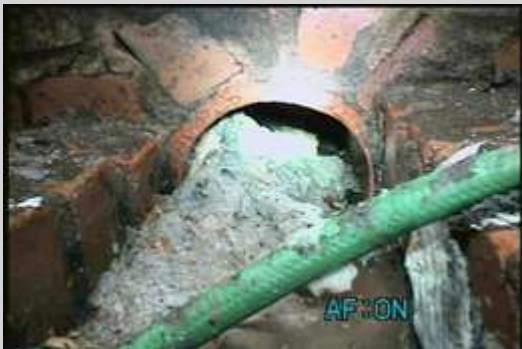
3 O'Clock Inflow

Deposits: ☐ None ☐ Mud ☐ Sludge ☒ **Debris** ☐ Grease

Silt Depth: 6 (in.) Deposits Extent: **Heavy**
